# TIN WHISKER FORMATION ON SMALL OUTLINE TRANSISTORS ASSEMBLED USING BISMUTH-CONTAINING LEAD-FREE SOLDER ALLOYS AFTER LONG-TERM AMBIENT TEMPERATURE, HIGH HUMIDITY STORAGE PART 3: IN-DEPTH CHARACTERIZATION AND MECHANISMS

André M. Delhaise<sup>1\*</sup>, Stephan Meschter<sup>2</sup>, Polina Snugovsky<sup>1</sup>, Jeff Kennedy<sup>1\*\*</sup>,  
Zohreh Bagheri<sup>1</sup>

This paper is the third in a series of three in which we share more in-depth characterization of features of interest from the small outline transistor (SOT) inspection. Discussion regarding the role of Bi in the overall stress state of the joint will also be provided.

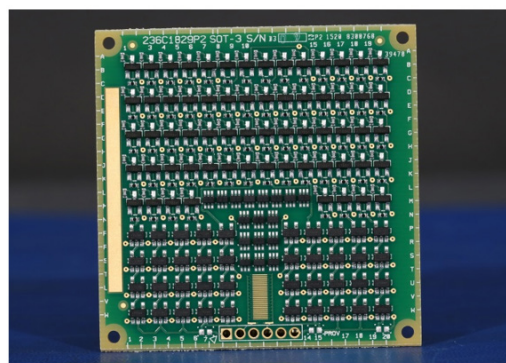
Figure 2: SOT test vehicle.

The types of test vehicles were assembled: SOT (small outline transistor) (Figure 2), QFP (quad flat pack) (Figure 3) and BGA/CAP (ball grid array/capacitor) (Figure 4). Details on the part types are given in the corresponding section of Part 1 of this work. The boards on the panels were soldered using solder pastes composed of the alloys and flux shown in Table 1. The SAC305 assemblies were soldered with a peak reflow temperature of 240 °C, while the bismuth containing alloys had a peak reflow temperature of 226 to 228 °C (as measured at the board surface).

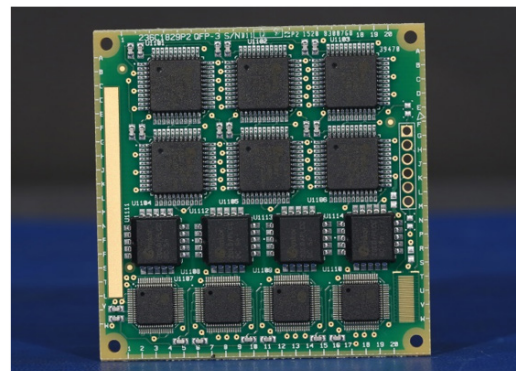
Figure 3: QFP test vehicle.

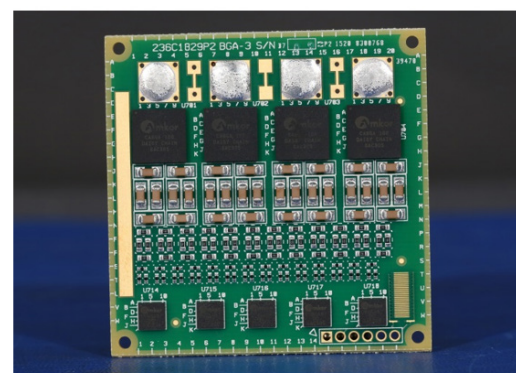
Figure 4: BGA/CAP test vehicle.

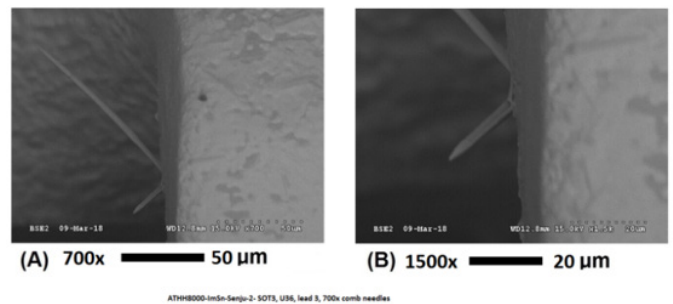
**Figure 5:** 12,000h inspection showing needle like structures on the bottom of the lead 100.8 and 24 microns long at the board pad edge on contaminated Imm Sn board pads with Senju solder (ImmSn-Senju-2- SOT3-U36-Lead 3 shown).

Several types of non-whisker stress relaxation growths were observed. In some cases, needle – like structures were observed without the characteristic striations or growth rings typically present on whiskers (Figure 5 to Figure 7). The longer needle-like structures were on the order of 100 microns (Figure 5 and Figure 6). Sometimes faceted growth was observed near the base of the needle growth and in one image was faceted features observed on top of the needle (Figure 7).

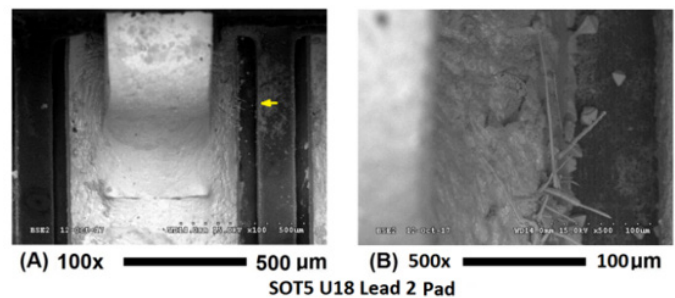
**Figure 6:** 12,000h inspection showing needle like structures at the board pad edge on contaminated Imm Sn board pad with Violet solder. The needle lengths in this cluster are: 125.1, 54.6, 20.2, 20.5, 59.1, 38.3, 37.6, 58.1, 20.7, 44.9, and 16.5 microns. (ImmSn-Violet-2C-SOT5-U18-Lead 2 shown).

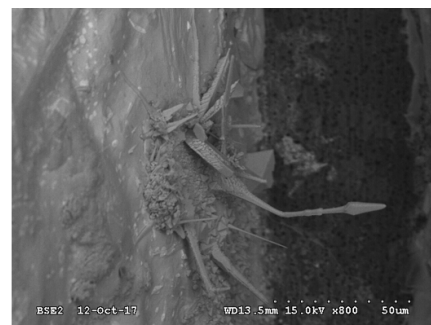
**Figure 7:** Needle like structures combined with faceted growth at the board pad edge observed during the 12,000h inspection on contaminated Imm Sn board pad with Violet solder. The needle lengths in this cluster are: 65.3, 30.7, 28, 14.2, 24.6, 23.6, 12.3, 13.5, 37.3, 17.2, 20.1, and 27 microns. (ImmSn-Violet-2C-SOT5-U11-Lead 5).

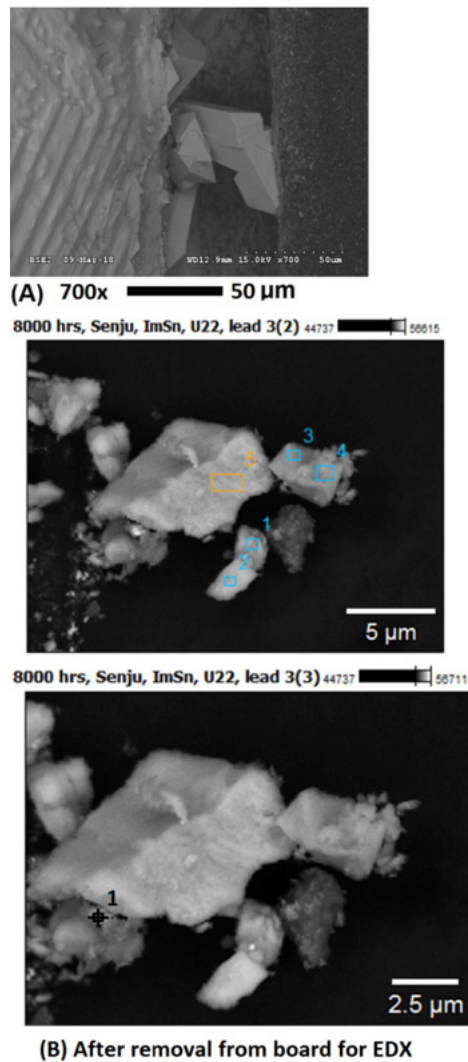
Weight%	O-K	S-K	Sn-L
lead 3(2)_pt1	29.94	0.19	58.86
lead 3(2)_pt2	33.32		54.91
lead 3(2)_pt3	32.05		45.18
lead 3(2)_pt4	26.96		50.85
lead 3(2)_pt5	13.71	0.27	82.03

Weight%	O-K	Cu-K	Sn-L	Bi-M
Lead 3(3)Pt1	20.25	1.92	69.45	1.66

**Figure 8: Faceted block like growth observed during the 12,000h inspection on the Imm Sn pad on a cleaned Senju soldered SOT3; (A) close-up of faceted growth and (B) EDX examination of the growth after removal from the board. (ImSn-Senju-2- SOT3, U22, lead 3 shown).**

Faceted growth without a needle-like structure was also observed on the pad edge (Figure 8). Faceted growth was previously observed on SAC305 solder joints after long term relatively benign simulated power cycling thermal cycling (Figure 9) [9]. Since the growth was in the small channel between the solder mask and the pad and had surrounding parts, an insitu EDX analysis could not be performed and the growth had to be removed. The growth was primarily Sn and O with a small Bi containing particle.

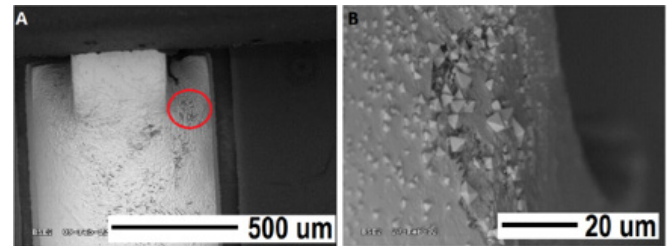
**Figure 9: Faceted growth observed during +50 to +85C simulated power cycling thermal cycling during the SERDP WP1753 test [9].**

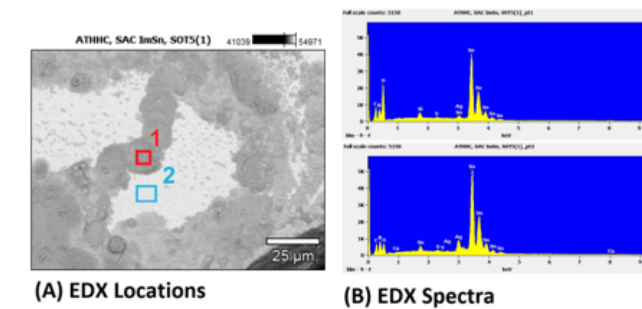
Weight %	C	N	O	Si	S	Cu	Ag	Sn
pt1	6.71	4.61	23.12	1.18	0.34		0.94	63.11
pt2	4.49	5.50	7.40		0.35	1.48	6.41	74.36

Figure 11: 4000h inspection showing EDX of corrosion on a contaminated SOT5 with SAC305 solder on an Imm Sn board finish; (A) EDX locations and (B) EDX spectra.

The corrosion on the SAC305 solder follows the Sn between the higher silver regions (Figure 11).

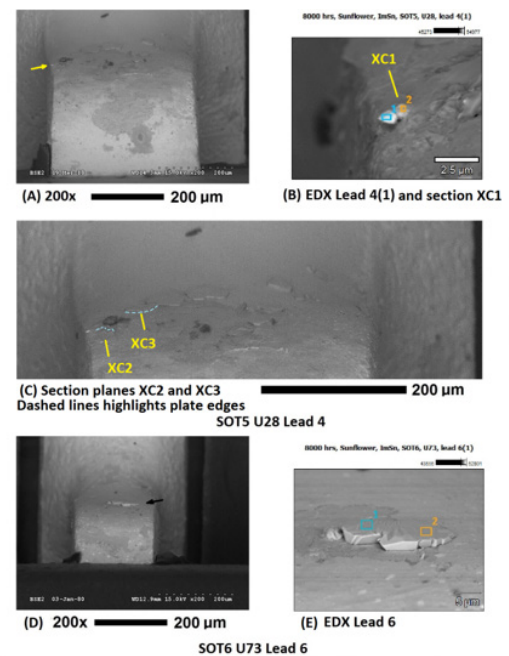
Weight % (C omitted)	O-K	Si-K	Cu-K	Sn-L	Bi-M
U28, lead 4(1)_pt1	12.82	0.64	3.68	10.72	69.05
U28, lead 4(1)_pt2	14.03		3.30	78.89	2.10
Weight %	O-K	Si-K	Cu-K	Sn-L	Bi-M
U73, lead 6(1)_pt1	26.26	2.88	0.68	65.62	
U73, lead 6(1)_pt2	24.64	4.77	1.71	57.80	3.56

Figure 13: Images and EDX analysis on SOT5 and SOT6 parts on a clean Imm Sn board with Sunflower solder after 12,000h; (A) overall SOT5 Cu lead showing whisker (black arrow), (B) EDX locations on whisker with Bi cap (see black arrow in A) and section plane XC1 location, (C) electronic image zoom of (A) showing several plate structures and section planes XC2 and XC3, (D) overall of SOT6 Ni42Fe lead with a similar plate structure, and (E) EDX of plate structure (see arrow in C). (images from ImSn-Sunflower-2)

The whisker and plate structures shown in Figure 35 in Part 1 were evaluated by EDX and cross-sectioning. The EDX results of the whisker (Figure 13A&B) show that the top is Bi and the base is Sn with 2.1Bi. The EDX results of the plate (Figure 13C&D) indicate that the plate is oxidized Sn with Cu and Bi. The cross-section of lead 3 was obtained while grinding to lead

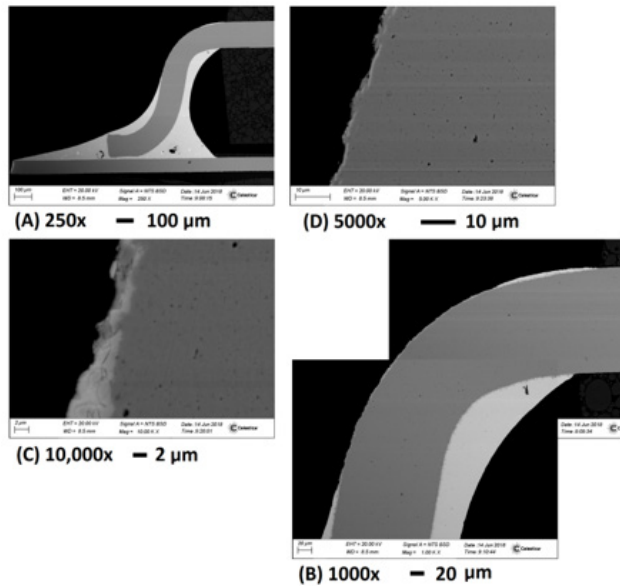
Figure 14: Cross-section of clean SOT5 U28 Lead 3 (polished before grinding to lead 4) after 12,000h; (A) overall, (B) composite close-up lead knee and top, (C) close-up of the solder transition from the bulk to the lead, and (D) close-up of the knee.

4 (Figure 14) and showed very little solder on the lead knee. XC1 on lead 4 shows that the whisker was above a Cu6Sn5 layer and that the whisker contained Sn, Cu and Bi (Figure 15). The intermetallic is less than one micron thick and suggests that the whisker growth may have stopped due to the elimination of tin in that area. Grinding further, XC2 shows a crack between the thin plate and the lead (Figure 16). XC3 shows a section into a larger plate structure (Figure 17) where the plate can be seen on top of a solder layer and the plate has cracks within it. The corroded surface has no dissolved Bi in the Sn. The plate is oxidized Sn2.1Cu with some Sn1.6Bi2.7Cu particles on top of a solder layer Sn2.1Bi2.9Cu solder.

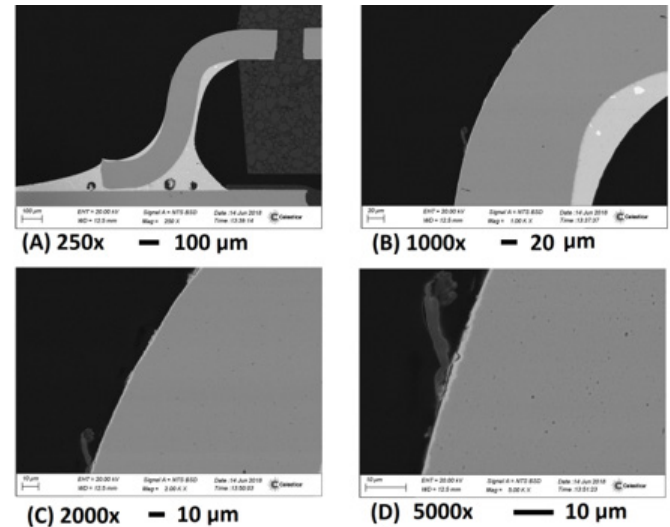
Figure 16: Cross-section of plane XC2 in Figure 13 on clean SOT5 U28 Lead 4 after 12,000h; (A) overall, (B), (C) and (D) increasing magnification images of knee.

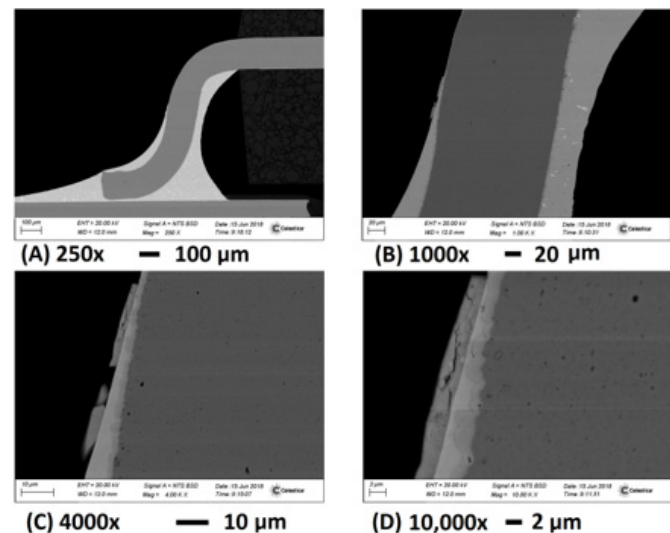
Figure 17: Cross-section of plane XC3 in Figure 13 on clean SOT5 U28 Lead 4 after 12,000h; (A) overall, (B), (C) and (D) increasing magnification images of knee.

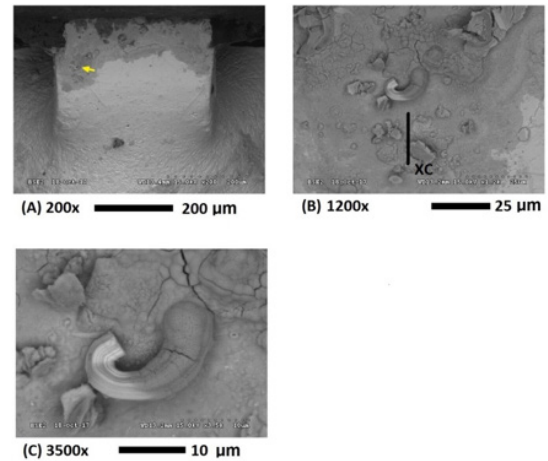
Figure 19: Images of a partially corroded whisker on a contaminated SOT3 on an Imm Sn board soldered with Senju solder after 12,000h; (A) overall, (B) close-up of whisker (see arrow in A) and location of cross-section plane, and (C) higher magnification image of whisker. The left side has not corroded. (ImSn-Senju-2C-SOT3-U36-lead 1 shown).

Examination of a partially corroded whisker at the top of a SOT3 lead on a contaminated Senju soldered assembly is shown in Figure 19. The cross-section through the whisker and the adjacent area where the corrosion/non-corroded lead surface demarcation occurs is shown in Figure 20. The solder thickness in this region along the knee is on the order of one micron. The EDX of the corrosion demarcation regions is provided in Figure 21. As was previously observed in the plate section, the corroded area does not contain Bi; while the non-corroded surface contains 1.9 weight percent Bi.

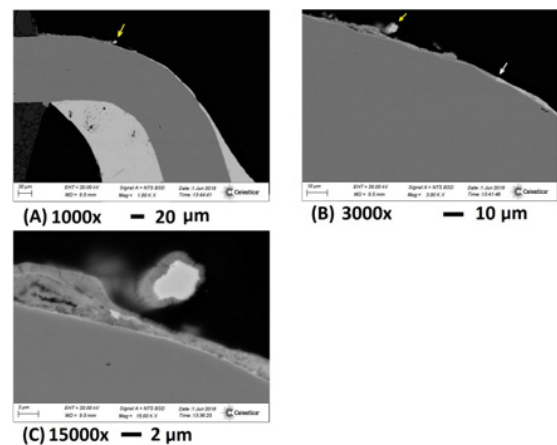
Figure 20: Cross-section of plane XC in Figure 19 of whisker and corrosion line of a contaminated SOT3 assembled with Senju solder after 12,000h; (A) overall with whisker shown by yellow arrow, (B) close-up near whisker (yellow arrow) with corrosion demarcation along plating (white arrow), and (C) higher magnification image of the whisker. (ImSn-Senju-2C-SOT3-U36-lead 1 shown).

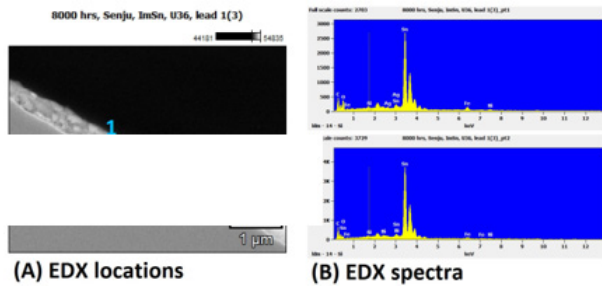
Weight% (C and Si omitted)	O-K	Fe-K	Ni-K	Ag-L	Sn-L	Bi-M
Lead1(3)pt1	17.98	2.86	1.44	1.56	70.95	
Lead1(3)pt2	4.36	1.45	1.19		86.19	1.93

Figure 21: EDX from the surface corrosion demarcation area in cross-section plane XC in Figure 19 (white arrow) of a contaminated SOT3 assembled with Senju solder after 12,000h; (A) EDX locations and (B) EDX spectra (ImSn-Senju-2C-SOT3-U36-lead 1 shown).

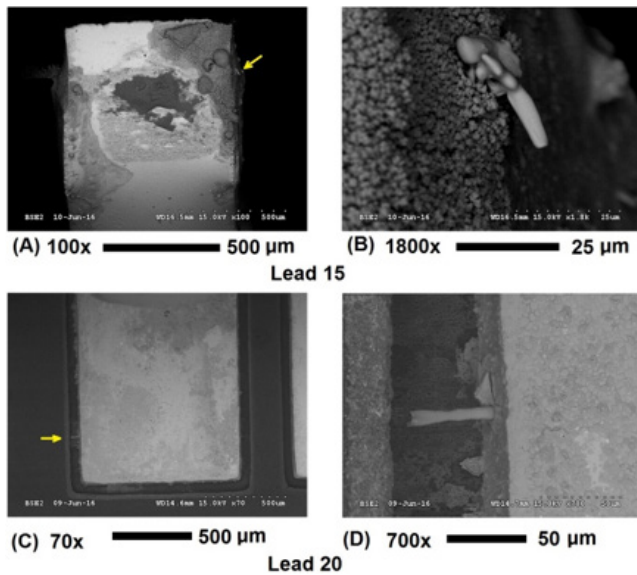
**Figure 24:** 4000h corrosion and whisker growth on Senju PLCC part on ImmSn board; (A) Lead with substantial corrosion, (B) Hollow whisker indicated by arrow in (A), (C) Pad with moderate corrosion and (D) Hollow whisker indicated by arrow in (C).

Some representative images (both ImmSn PLCC parts) from Senju and Sunflower are shown in Figure 24 and Figure 25. The Sunflower lead in particular had a large number of whiskers on the lead shin (L4) which warranted further investigation.

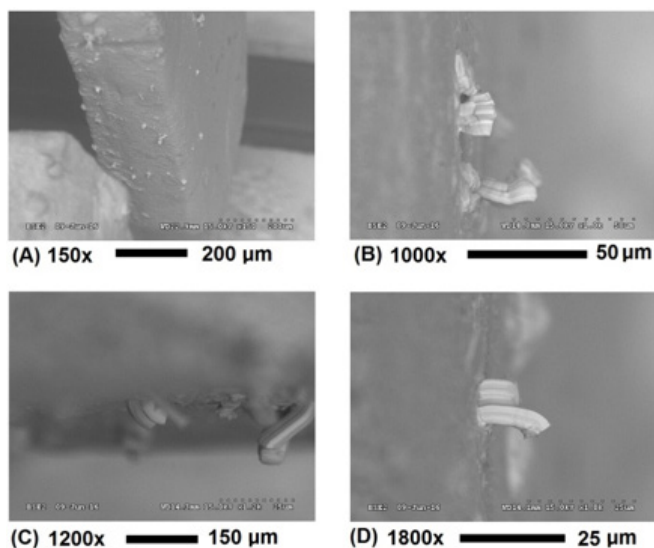
**Figure 25:** 4000h whisker growth on Sunflower PLCC part on ImmSn board; (A) Lead with many whiskers on L4 and (B-D) Higher magnification images of some of the whiskers on the lead in (A).

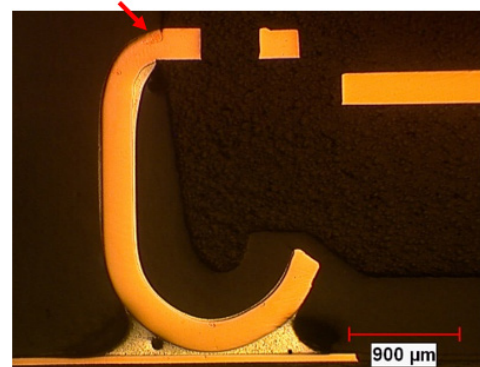
**Figure 26:** Cross-section of as-assembled PLCC part. Arrow indicates approximate location of SEM/EDX analysis.

It is known that reflowing Sn plating will remove features such as residual plating stress and trapped organic contaminants from the plating process. As indicated earlier in this paper, SAC 305 assemblies were reflowed at a peak temperature of 240°C, while the assemblies with Bi-bearing alloys were reflowed at a peak temperature between 226°C and 228°C. The peak temperature of the latter is below the melting point of Sn, and thus plating artifacts are more likely to remain after reflow on parts on these assemblies, particularly if the solder cannot wick up the entire lead (Figure 26). A quick inspection of PLCC parts (at location

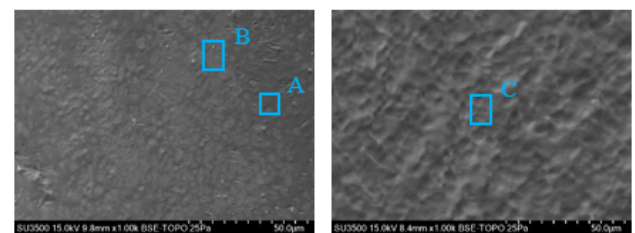
Site	Sn (wt%)	Cu (wt%)	Si (wt%)
A	96.4	2.0	1.6
B	71.3	27.3	1.4
C	99.0	0.0	1.0

**Figure 27:** SEM images of plating morphology and EDX results on as-assembled PLCC joints at L3; (left) SAC 305 and (right) Sunflower

L3) in the SEM indicated that this was indeed the case – the part assembled with Sunflower paste retained most of its original plating structure, while the SAC 305 sample appeared to reflow (Figure 27). This was further supported by EDX; parts reflowed with SAC showed regions richer in Cu, indicating a reaction occurred between the Sn plating and Cu lead base metal (which would only occur if the Sn were to melt), while the Sunflower sample did not show any regions with Cu.

These results indicate that while residual plating artifacts may contribute to whisker formation, the reaction of the Sn with the Cu base metal in SAC 305 to form IMCs may also contribute to whisker growth via the coarsening of these particles over time.

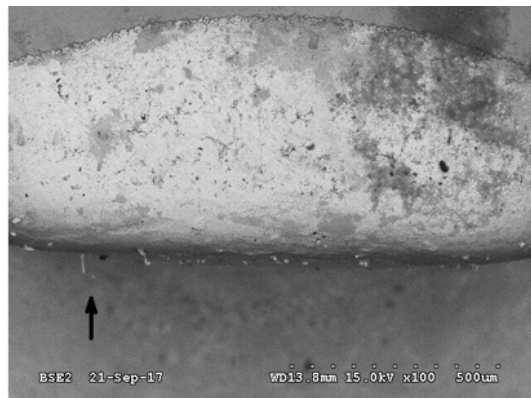
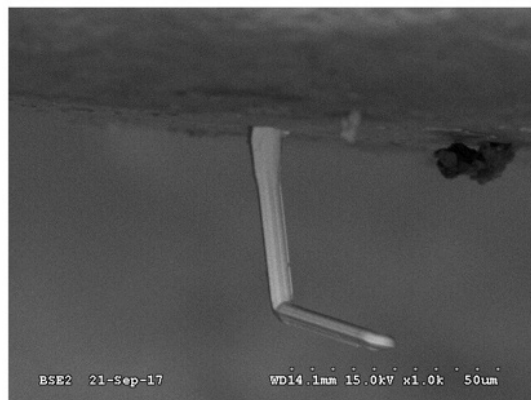
Figure 28: 12,000h inspection showing whisker growth from a larger capacitor on a contaminated BGA/CAP board; (A) overall image and (B) close-up of whisker (arrow in A). (ImSn-Violet-Cap-3C shown).

Whiskers were found on the capacitors and resistors during a screening inspection of contaminated assemblies at 12,000h. No whiskers were found on the corresponding cleaned assemblies. Some of the whiskers on the order of 50 microns were observed (Figure 28) and were often above the main solder fillet (Figure 29). In some cases, however, whisker growth and faceted growth was observed from the solder near the ceramic (Figure 30). Additional images are provided in Appendix I from the original conference publication of this work.

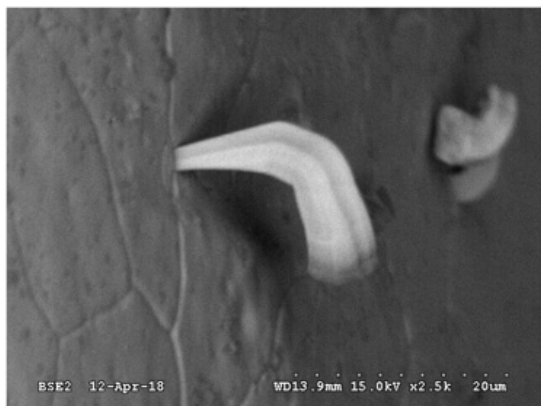
Figure 29: 12,000h inspection showing whisker growth from 1206 capacitor on a contaminated BGA/CAP board; (A) overall image and (B) close-up of whisker. (ImSn-Violet-2C-big cap 1 shown).

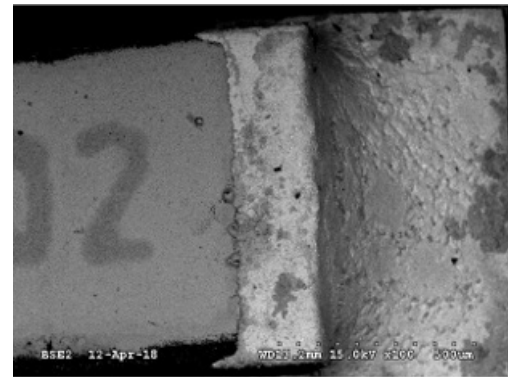
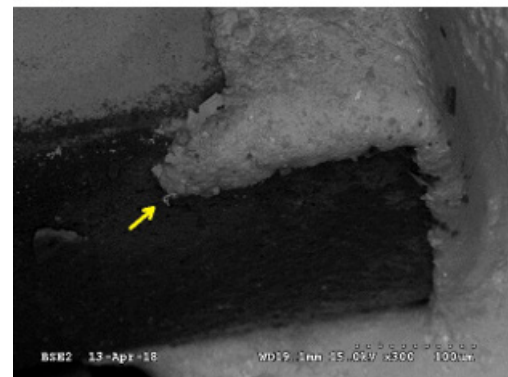
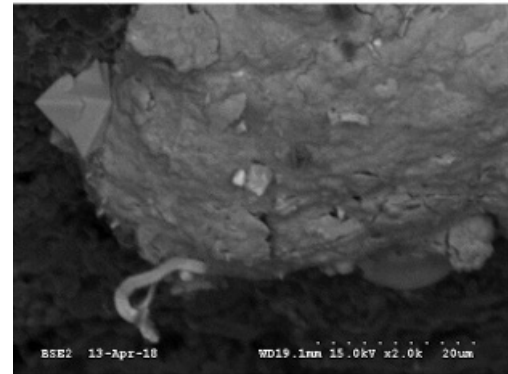
ATHH8000-ImSn-Violet-2C-large res 2, 100x

Figure 30: 12,000h inspection showing whisker growth from a resistor on a contaminated board (ImSn-Violet-2C-large res 2 shown).

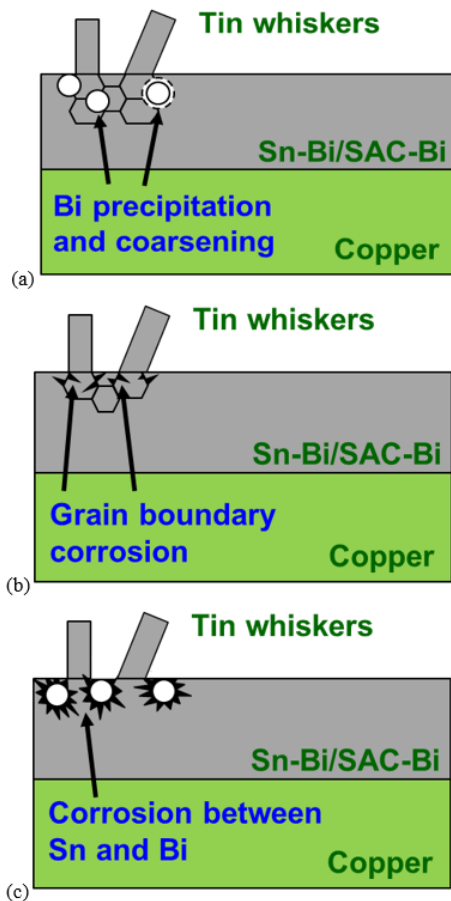
Figure 31: Schematics illustrating the effects of Bi on tin whisker growth; (a) Precipitation and coarsening of Bi over time induces Sn to recrystallize into small, uniform grain structure, (b) Increased grain boundary content in the alloy results in increased grain boundary corrosion, and (c) Corrosion (galvanic or phase boundary) of Sn in proximity to Bi.

- Contamination increases stress from corrosion substantially
- Precipitation of Bi causes Sn to recrystallize (Figure 31a). This both increases stress as grain boundaries are susceptible to corrosion (Figure 31b), but also dissipates stress evenly throughout the joint and the likelihood of long whiskers (higher, more localized stress) can be reduced.

- Bi may form a galvanic couple and phase boundaries with Sn which increases stress from corrosion (Figure 31c)
- Ni in Alloy 42 lead and ENIG surface finish may mitigate corrosion and refine IMCs compared with Cu194 lead and ImmSn finish respectively, decreasing stress.

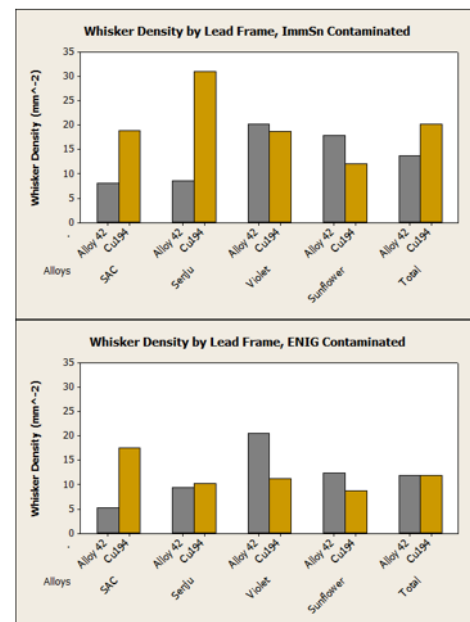
Figure 32: Whisker density on contaminated ImmSn (top) and ENIG (bottom) assemblies, organized by lead frame material for each alloy.

As observed in Figure 32 (also shown in Figure 13 from Part 2 of this work) Figure 32, as the Bi content in the alloy is increased, whisker density increases on Alloy 42 and decreases on Cu194. Alloy 42 contains Ni, which may mitigate corrosion and IMC coarsening, and the stress induced is initially low. Additions of Bi increase the stress state (via precipitation and corrosion), but not sufficiently high enough to be 'outside' the sweet spot, resulting in increased whisker density. For Cu194, the stress state is likely initially higher than Alloy 42 as there is no Ni in the lead frame. Bi additions increase the stress – for Senju on ImmSn, the whisker density was observed to be very high, possibly because the total stress remained within the sweet spot. Further additions of Bi (for Violet and Sunflower) may raise the stress state to be higher than the sweet spot, resulting in lower density. This is a possible reason why the whisker density is higher on Alloy 42 than Cu194 for alloys with high Bi content, which is opposite to what is seen on SAC 305 joints.

This high density on the ImmSn-Senju-Cu194 combination may also be related to the interaction of corrosion product with whiskers. This combination may represent some 'optimal' corrosion conditions in which fewer numbers of whiskers are consumed or broken by corrosion. Other combinations, such as with Violet or Sunflower, may produce more whiskers than were actually observed, but corrosion of whiskers was sufficient to reduce whisker density during inspection. More frequent VP-SEM inspections would likely ascertain whether this is indeed the case.
