# An Investigation on the Influence of Nickel Contamination on Thermal Fatigue Reliability of Jumper Pins Plated Through Hole (PTH) Solder Joints

**David Hillman, Tim Pearson, Ross Wilcoxon, Parker Jacobson**  
*Collins Aerospace*

## ABSTRACT

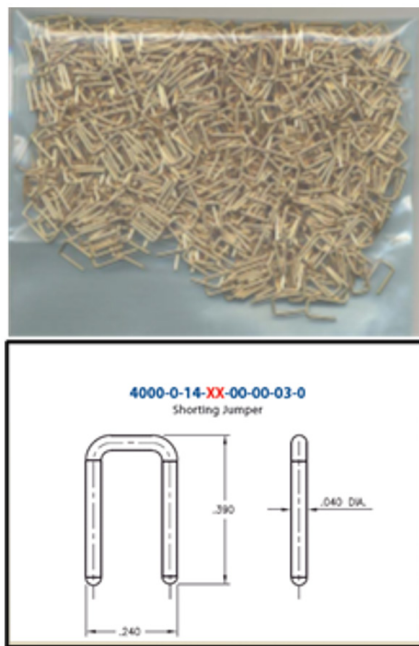
The test components were Mill-Max shorting jumpers to simulate plated through hole components and enable the use of event detector electrical resistance monitoring equipment. The primary shorting jumper had a surface finish of 10 microinch gold over nickel (Au/Ni) underplating on a brass pin, representing a nickel contribution worst case. A small number of shorting jumpers had a surface finish of 200-300 microinch tin plating over nickel (Sn/Ni) underplating on a brass pin, which allowed for the inclusion of a potential “tin whisker observed variable” in the investigation. Figure 2 illustrates the shorting jumpers used.

Figure 2. Investigation Test Components (Top: As Received Parts, Bottom: Jumper Dimensions)

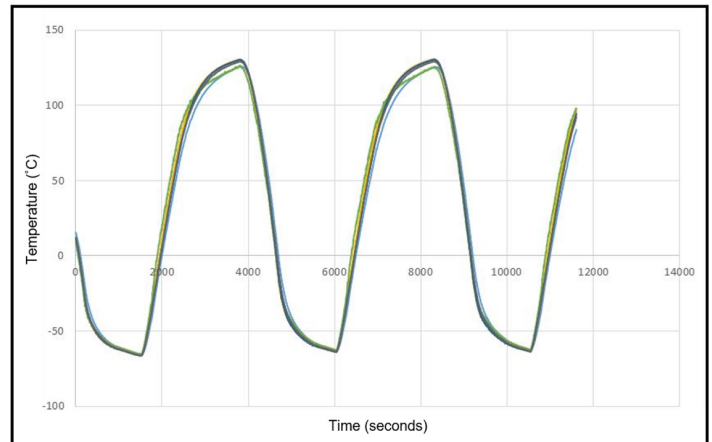
Figure 4 illustrates the test vehicle "brick" prepared for testing while Figure 5 shows the thermal cycle temperature profiles measured on multiple test boards. A total of 7,581 thermal cycles were completed.

**Figure 5. Thermal Profile**
